Masonry Walls for
Impact Resistance

*Man-made Impact and Abrasion
Weather Related Damage
Ballistics Research - RCMP Study
Explosion/Blast Resistant Construction*

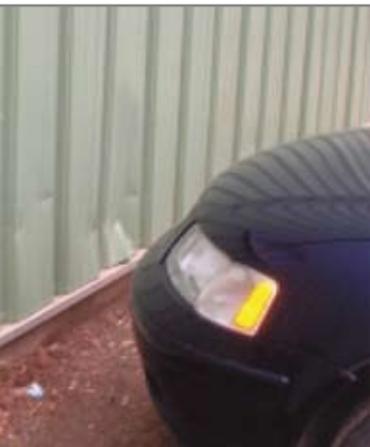
Steel cladding dented by parking cars.

“Impact resistance” with regard to construction means the ability of building materials to resist repetitive contact or accidental impact without damage. Exterior walls of steel, aluminum or vinyl siding, stucco or wood will often not withstand impact without damage, unlike masonry walls.

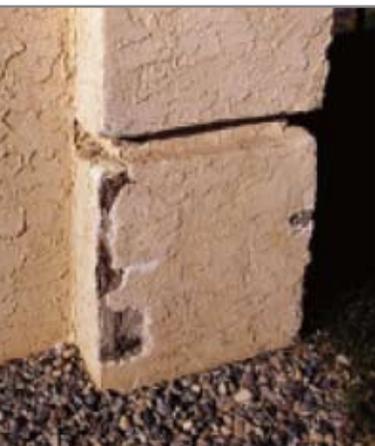
Stucco corner abrasion due to human traffic.

Building interiors are also subject to wear and tear from human traffic. Masonry resists abrasion far better than drywall finishes, particularly for institutions such as schools and hospitals.

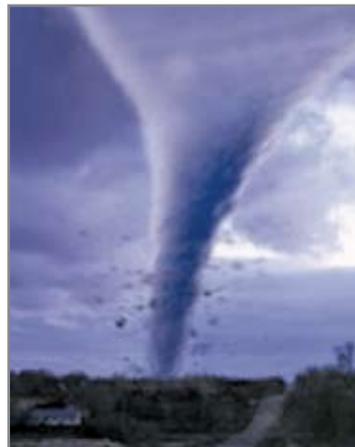
High winds turn debris into missiles.

The house in the above photo was seriously damaged by hail and required complete replacement of the vinyl siding while the brick easily withstood this storm.

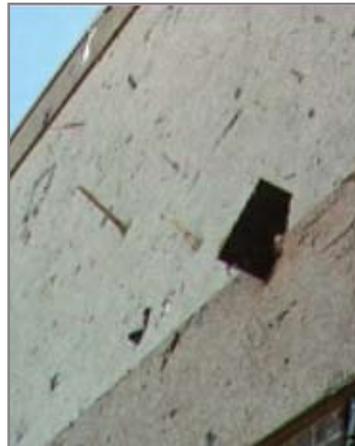
EIFS penetrated by wind-blown debris.

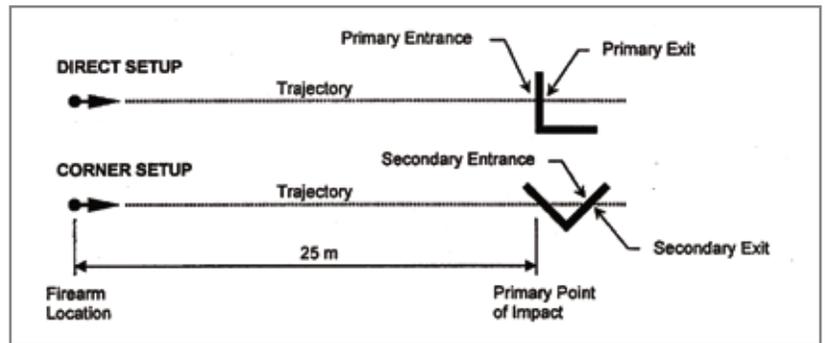
This diagram shows the trajectory of the bullet and wall orientation during testing.

The walls were tested in the firing range at the Royal Canadian Mounted Police (RCMP) forensic laboratory located in Edmonton, Alberta. Testing was performed on one wall at a time at a horizontal distance of 25 metres from the location of the firearm. Shots were taken straight on and through a corner.

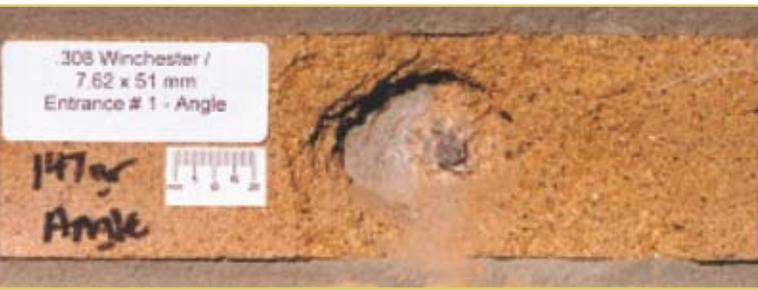
Above photo shows entrance point of impact. Bullet failed to pass through brick wall.

Photos taken at RCMP Forensic Lab of test panels using common .308 Winchester rifle (cartridge size 7.62 x 51 mm).

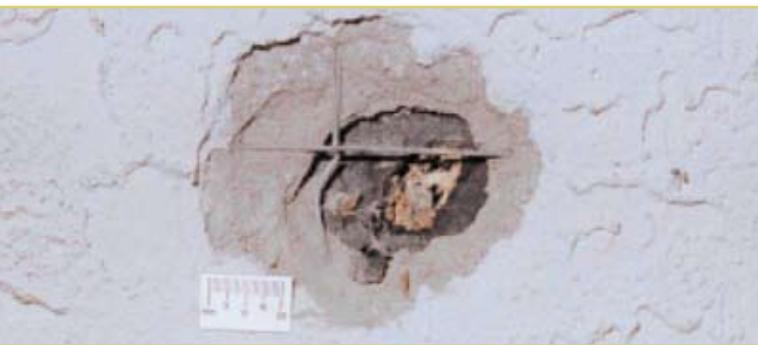
Above photo shows exit point of stucco wall after bullet has passed through corner (i.e. two complete walls).

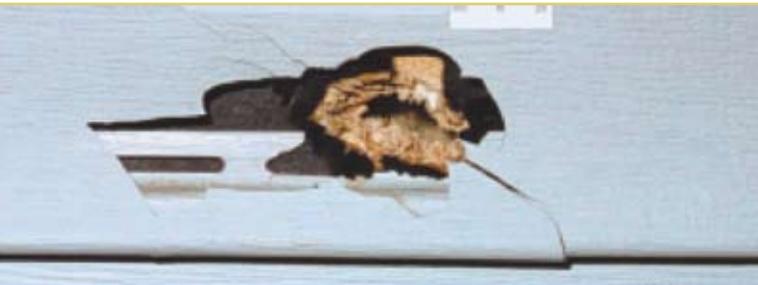
Above photo shows exit point of vinyl sided wall after bullet has passed through corner (i.e. two complete walls).

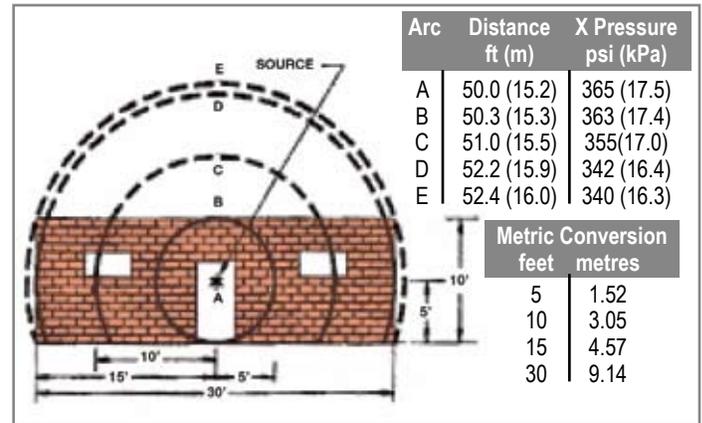
The above diagram shows the pressure distribution model from 25 lbs of TNT with standoff distances of 50 feet and 5 feet above the ground. Masonry, designed effectively, can provide a first line of defence against blast impact.
